Example of Extremely Low Frequency (60 Hz) Causing Electrical Failure

Thermal radiation inspections for oil, gas, energy, petrochemical, manufacturing, lumber, mines, insurers, etc are to isolate electrical problems before they fail. Failure can cause explosions, fire, injury, loss of life, production and economic losses.

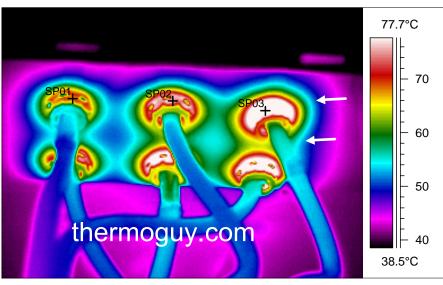
| IR information | Value |
| Date of creation | 7/11/2002 |
| Time of creation | 9:03:22 AM |
| Label | Value |
| IR : max | 88.3°C |
| IR : min | 34.6°C |
| SP01 | 68.9°C |
| SP02 | 76.2°C |
| SP03 | 88.2°C |

The IR image above are called parallel feeds, big wires feeding a Motor Control Centre in a lumber mill. Electrical professionals accommodate the EMFs around **each** conductor using a non magnetizing insulating board. This installation didn't use the Mica board so the 60 Hz EMFs are inducing currents and causing the molecules of affected metal cabinet to change direction 120 times per second. Metal doesn't change direction easily and heat is a byproduct. The wire insulation is rated for 90 deg. C. and close to being exceeded. Breakdown in insulation would result in a groundfault and violent explosion. This is with extremely low frequencies.
