**Re: Energy Waste, Nuclear Energy, Smart Meters & Severe Weather**

## MISSING INSULATION BEHIND DRYWALL

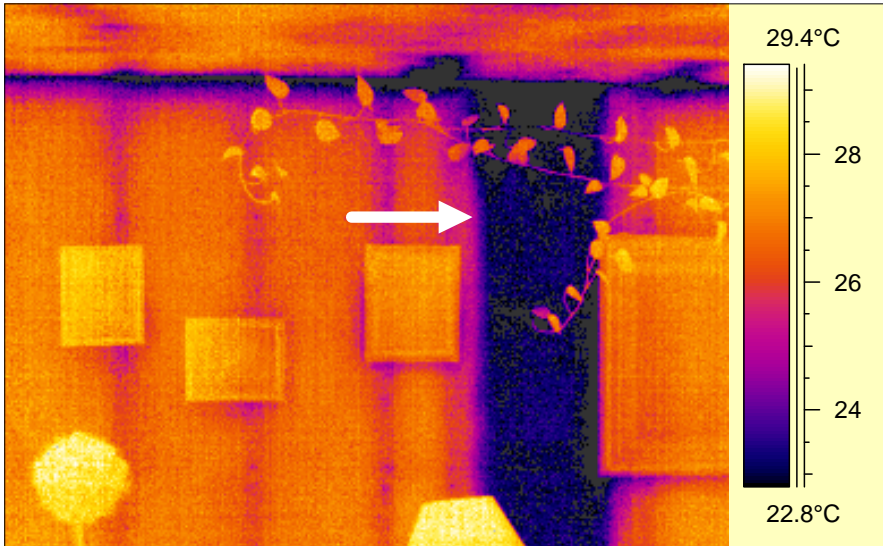
The exterior wall image above shows missing insulation values in one stud space. The problem should have been addressed while under warranty but was missed in the inspection.

A blower door test testing for pressure differential wouldn't have caught the problem either.

This is energy loss, fossil fuel and electricity waste producing more GHG emissions. There is a potential for mold and premature failure of building components. That affects the home owner's heat and investment.

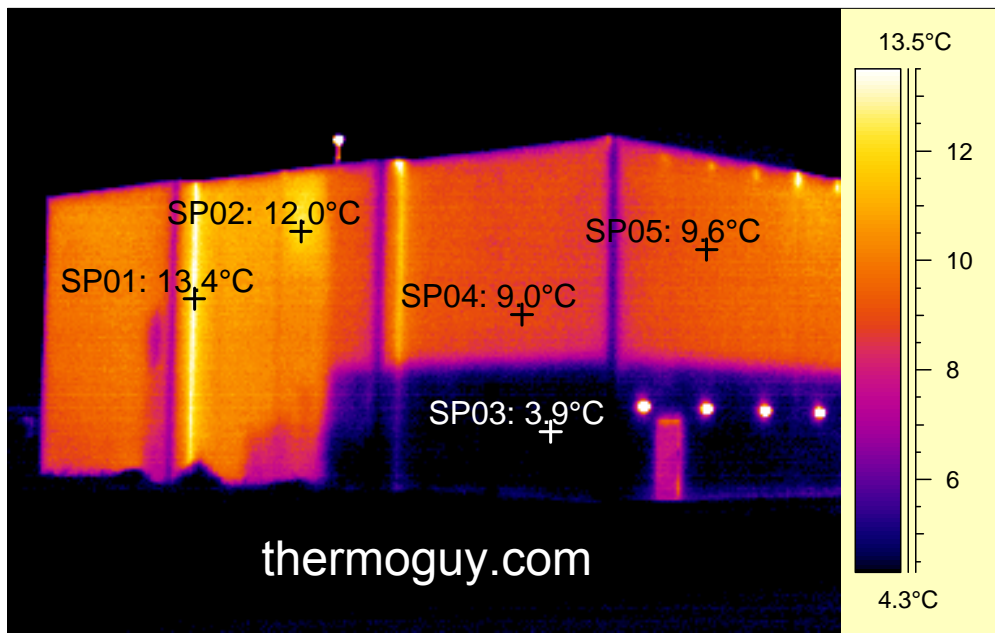
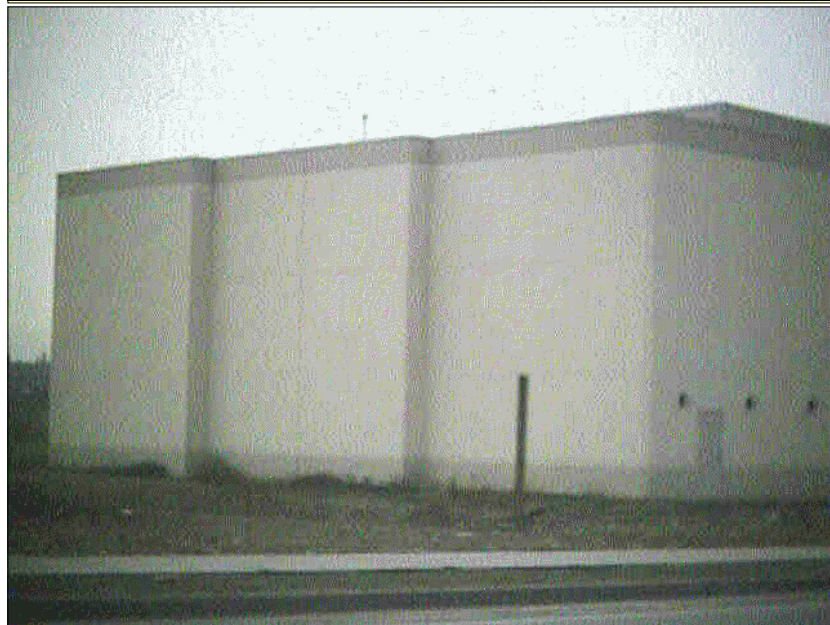
### **New Building Illegal But Passed All Inspection**

**4 Deg. C Day, Dark Area is Insulated Showroom.**

**Tilt up Construction, No Insulation, Heaters on Roof and Heat Rises.**

**Mass of Uninsulated Concrete Structure Heated.**

**Building Services Working Overtime, Energy Waste, More Emissions.**

**A/C is Refrigeration Wasting 1000s of Watts Per Hour Per Building.**

**Blower Door Test Not Addressing the Energy Loss or Saving Energy**

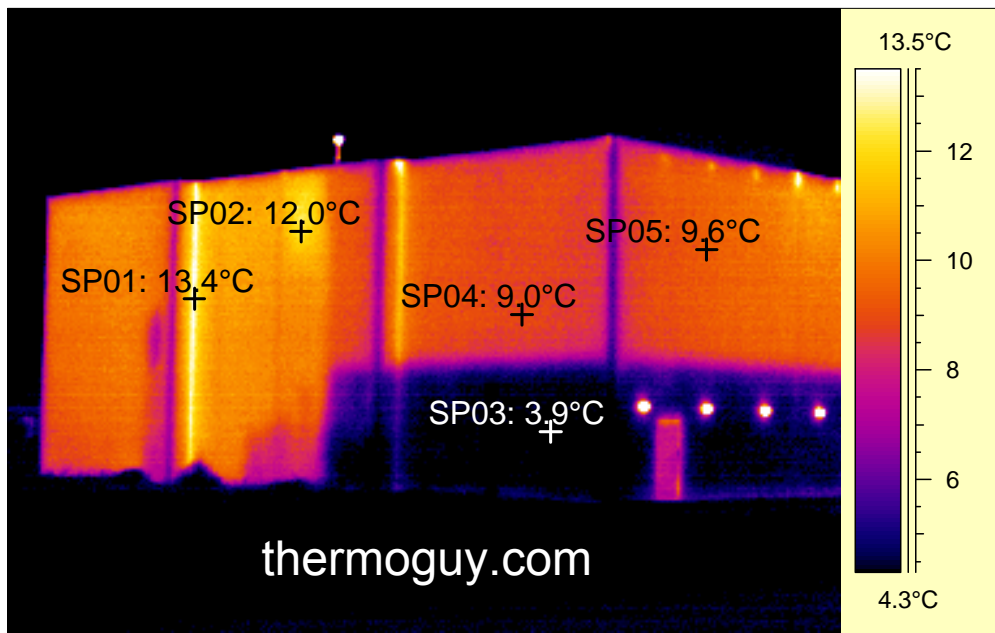
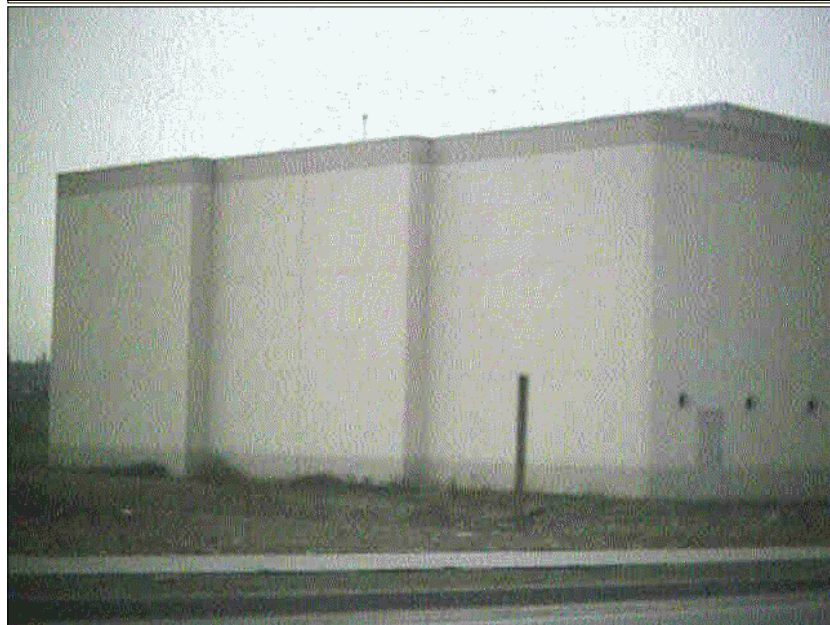
### **New Building Illegal But Passed All Inspection**

**4 Deg. C Day, Dark Area is Insulated Showroom.**

**Tilt up Construction, No Insulation, Heaters on Roof and Heat Rises.**

**Mass of Uninsulated Concrete Structure Heated.**

**Building Services Working Overtime, Energy Waste, More Emissions.**

**A/C is Refrigeration Wasting 1000s of Watts Per Hour Per Building.**

**Blower Door Test Not Addressing the Energy Loss or Saving Energy**

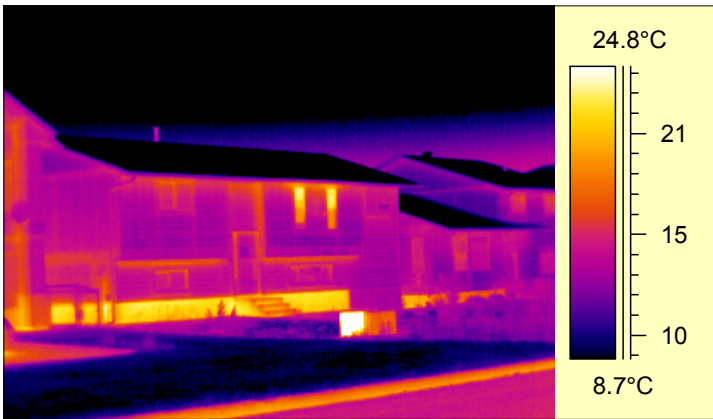
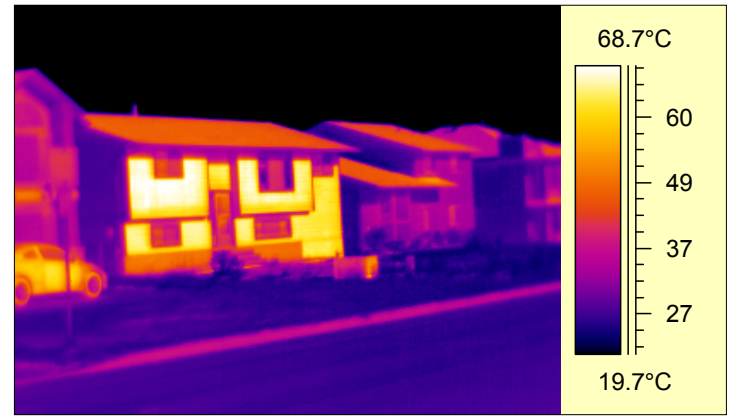
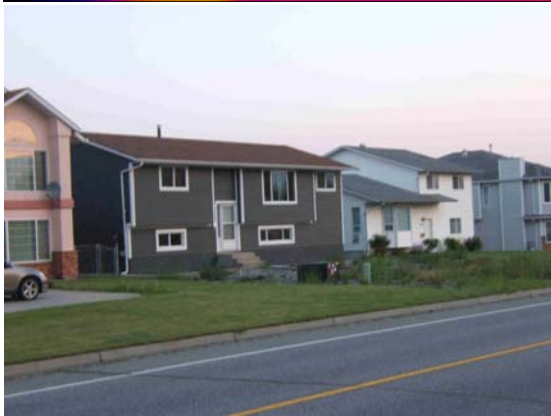
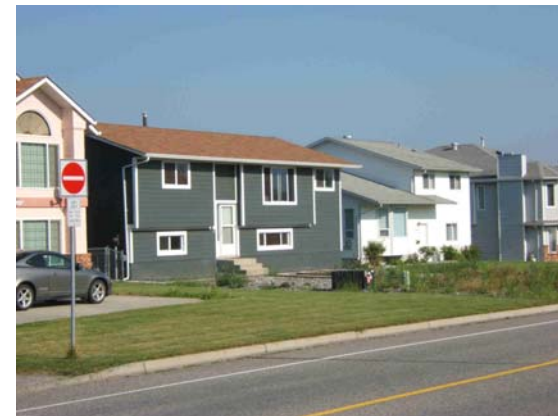
**Before Sunrise**

**After Sunrise**

The images above show the same buildings before and after sunrise. Use the temperature scale to the right of the infrared image to see the exterior of the dark colored building is 69 deg. C at 8:24 A.M. According to building code, the building is designed and insulated for a maximum of 33 deg. C.

When heat is generated, the heat radiates atmospherically and transfers inside the building.

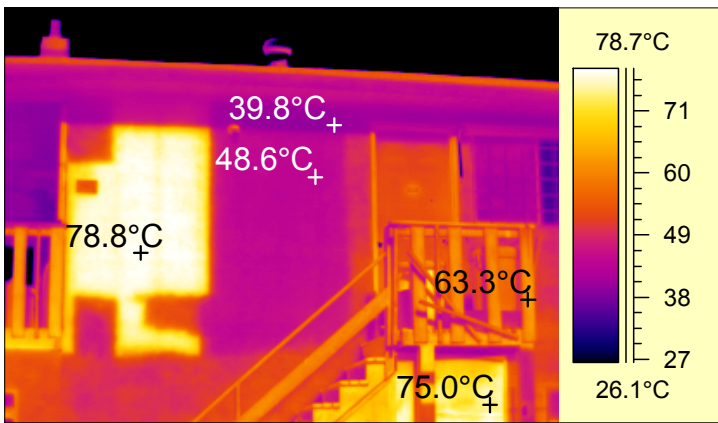
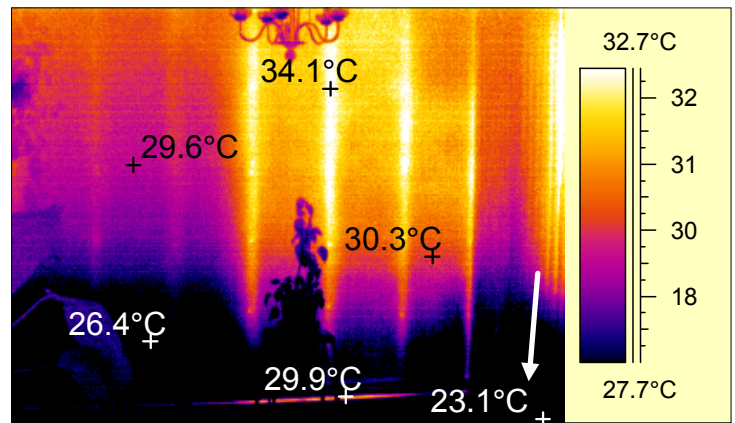
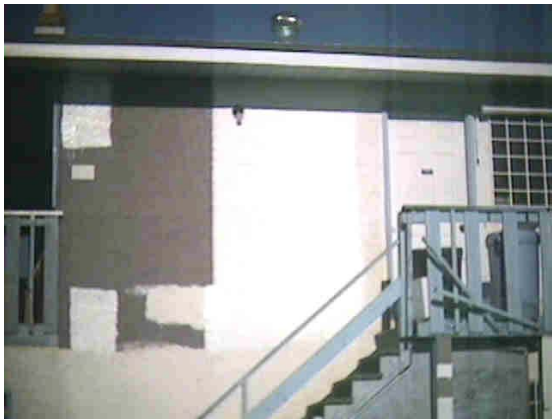
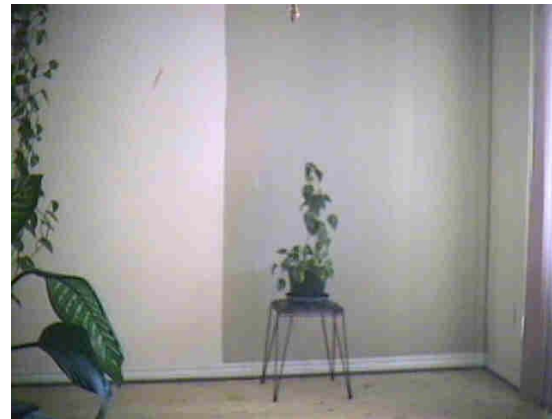
**Exterior Wall**

**Inside Exterior Wall**

We painted an exterior wall 2 different colors and imaged the wall on both sides to see solar impact in the early evening. Use the zoom features to magnify areas of interest. Use the scale to the right of the infrared image for color/temperature reference and the Result Tables below each image for additional infrared information.

The exterior wall is designed and insulated for a maximum of 33 deg. C. At 6:02 PM the darker area is 46 deg. C above maximum design temperature.

The image top right shows the affect inside the building. The heat from the solar exposed exterior tranfers inside the building through the wood frame and insulated wall.

Observe the difference in heat transfer between sides with the dark and lighter exterior colors at 7:52 PM. Lumber is a poor conductor and holds the heat till early in the morning.

The white arrow is highlighting the vent where the air conditioning enters the room. Air conditioning(A/C) is in fact refrigeration and the cold heavy air is laying on the floor creating a mold environment. The A/C unit is using 3450 watts per hour reacting to symptoms. That is 34- 100 watt light bulbs on full time and all of it reacting to symptoms. Producing more emissions wasting fossil fuels and creating an unhealthy home.

Dew point between the two indoor weather systems meeting creates mold.

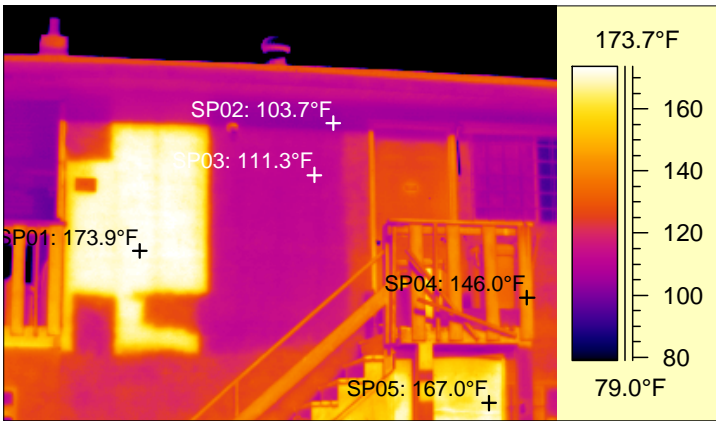
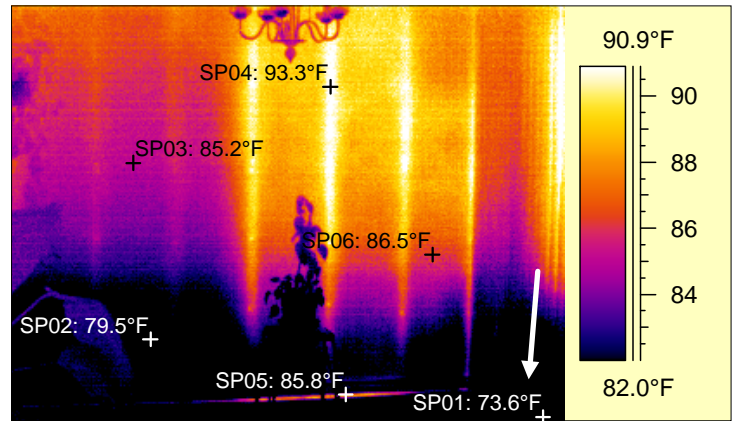
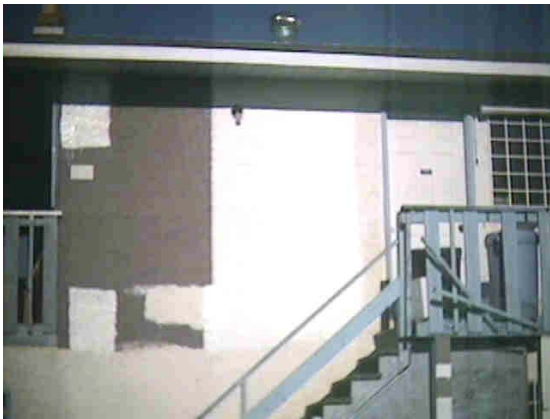
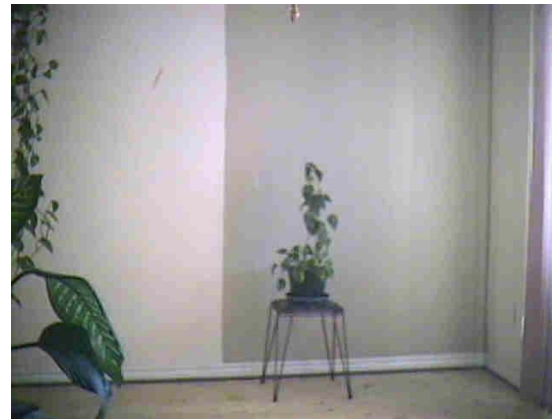
**Exterior Wall**

**Inside Exterior Wall**

We painted an exterior wall 2 different colors and imaged the wall on both sides to see solar impact in the early evening. Use the zoom features to magnify areas of interest. Use the scale to the right of the infrared image for color/temperature reference and the Result Tables below each image for additional infrared information.

The exterior wall is designed and insulated for a maximum of 92 deg. F. At 6:02 PM the darker area is 94 deg. F above maximum design temperature.

The image top right shows the affect inside the building. The heat from the solar exposed exterior tranfers inside the building through the wood frame and insulated wall.

Observe the difference in heat transfer between sides with the dark and lighter exterior colors at 7:52 PM. Lumber is a poor conductor and holds the heat till early in the morning.

The white arrow is highlighting the vent where the air conditioning enters the room. Air conditioning(A/C) is in fact refrigeration and the cold heavy air is laying on the floor creating a mold environment. The A/C unit is using 3450 watts per hour reacting to symptoms. That is 34- 100 watt light bulbs on full time and all of it reacting to symptoms. Producing more emissions wasting fossil fuels and creating an unhealthy home.

Dew point between the two indoor weather systems meeting creates mold.

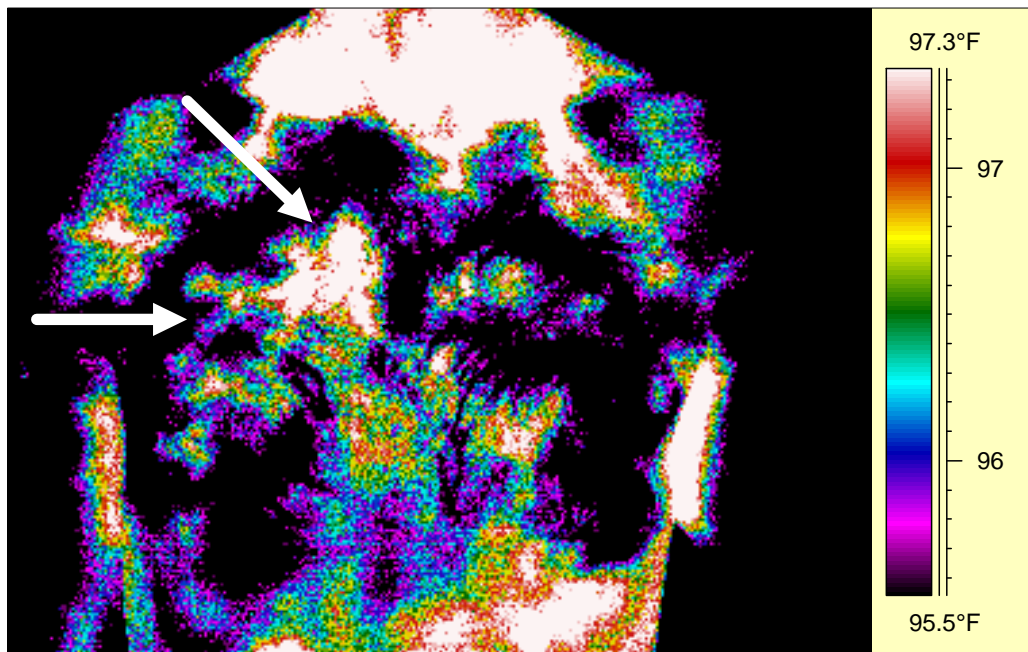
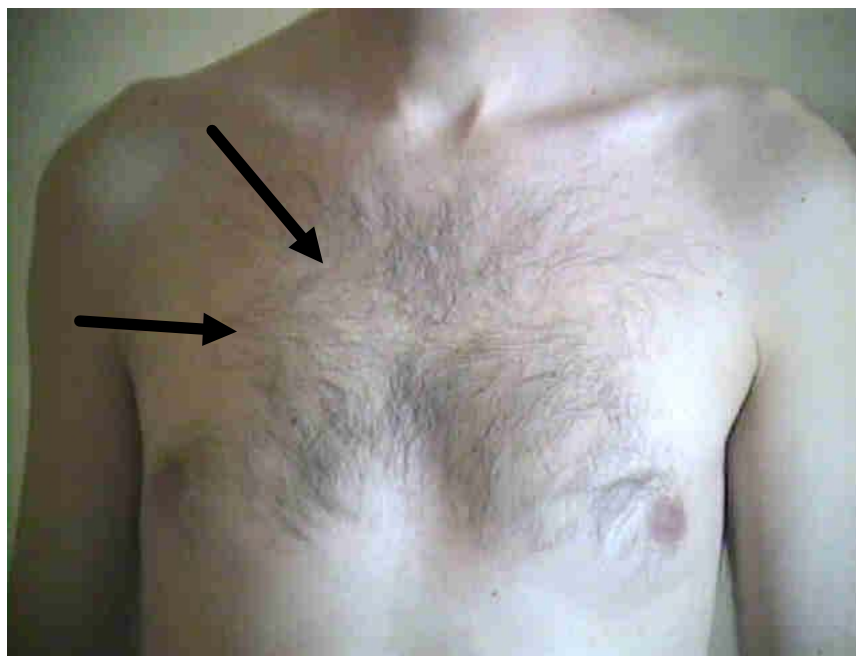
## Lung Inflammation

The gentleman in the images above has difficulty breathing and we were asked to image him to see if a lung problem could be seen or isolated.

Although there is a lot of temperature information in the image, the arrows are highlighting the source of inflammation. You can actually see the shape of the inflamed lung and there is more inflammation in one area.

The source of his health challenge was a mystery until it was attributed to a mold environment inside his residence. The exterior of his building was a dark color and the A/C ran all day addressing the indoor heat.
